## 10 YEAR MANUFACTURER'S

### LIMITED WARRANTY

# **KINGSTON BRASS**

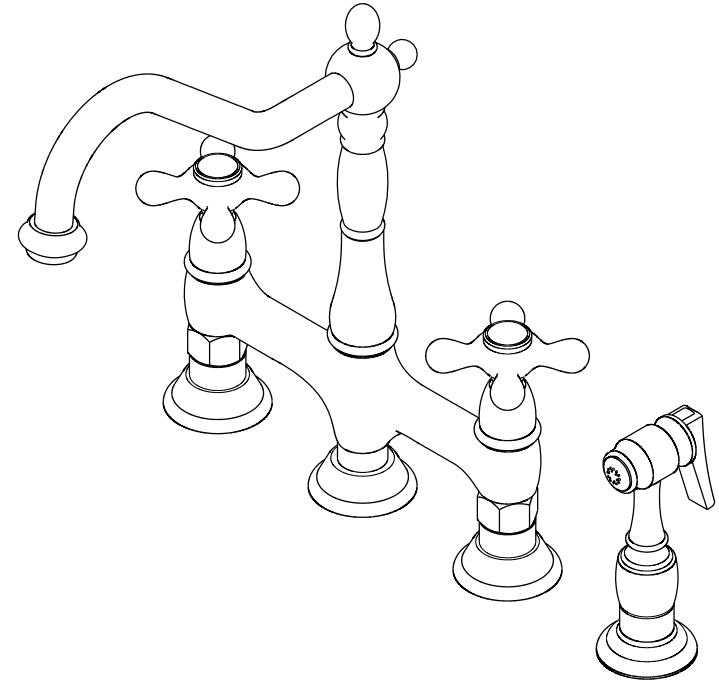
### **Parts:**

| Lock Nut | Cone Washer & Coupling Nut |
| 2 Pcs | 2 Pcs |
